Biogen Biogas Generation Facility

Atherstone, Warwickshire, United Kingdom

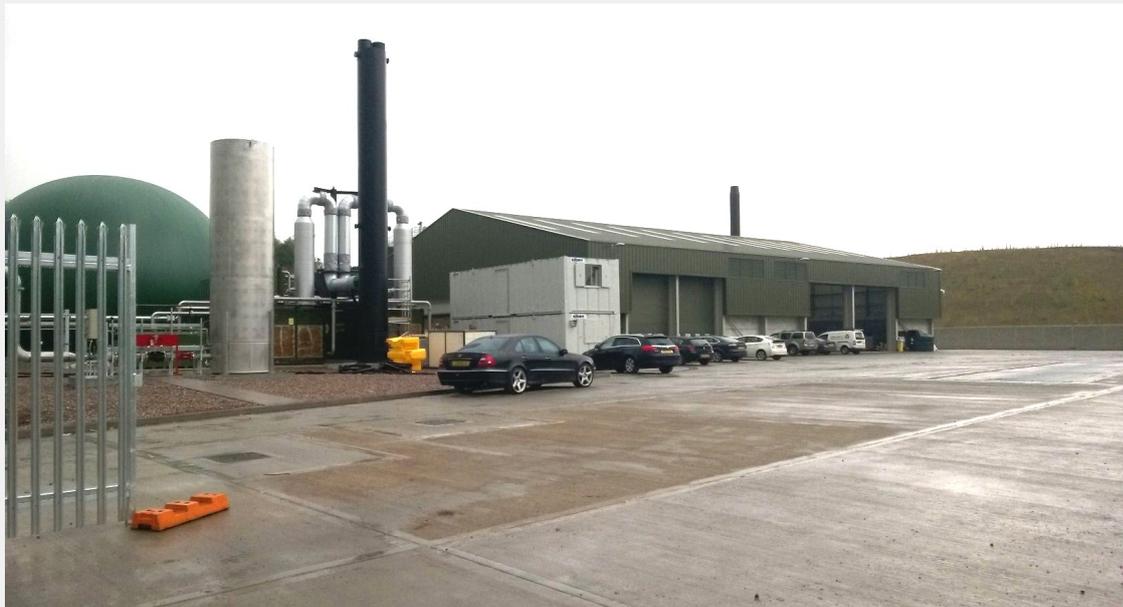
Biogen operates a number of biogas facilities across the UK, where organic waste is fermented to produce methane gas for fuel. The organic liquid waste is acidic in nature, and therefore poses a high risk of corrosion to conventional steel fabric. Adfil fibres provide a better solution.

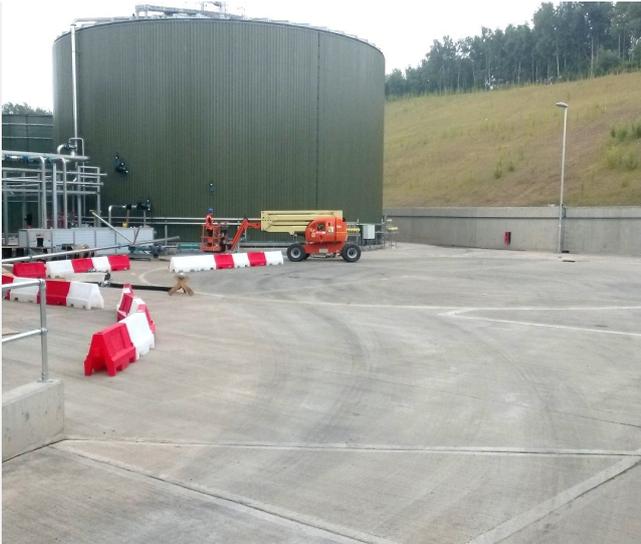
Acidic organic waste is stored in large fermenter tanks before the gas is drawn off; the risk of corrosion in this area is now eliminated

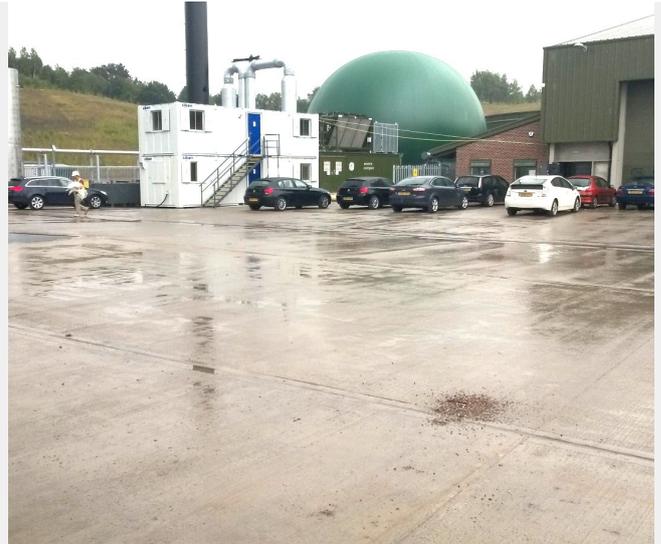
Large areas of pavement could be poured and then saw cut contraction joints made, without delays from steel fixing

Installation of the FRC (Fibre Reinforced Concrete) pavement saved approximately two weeks of steel fixing, and also allowed a busy site to maintain an efficient works programme, as traffic movement were not hindered by in-situ steel fabric placement and storage.

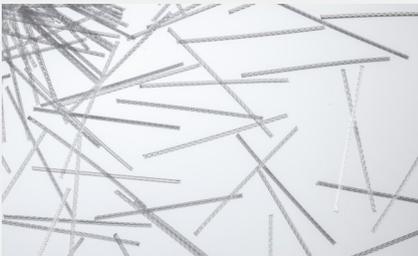
DURUS S400

Macro fibre made out of polypropylene. Improves the bond with the concrete.

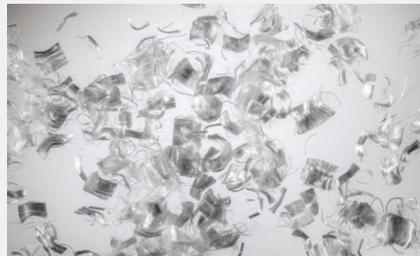
Fibrin XT

Micro fibre made out of polypropylene. Reduces plastic shrinkage.
