Butterley Reservoir Spillway

Marsden, West Yorkshire, UK

Butterley Spillway provides an overflow to divert surplus water from the Butterley Reservoir and prevent flooding to the surrounding towns and villages. Since its construction in 1906, the Victorian Spillway had severely deteriorated over time and was in need of urgent renovation and remedial repair works.

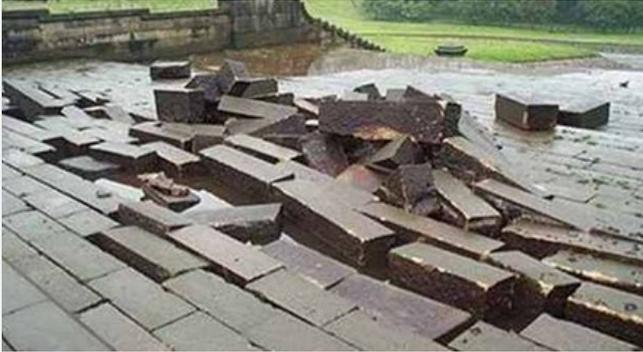
The Victorian Reservoir Overflow is handcrafted Stone Masonry and forms the Channel which is Grade II Listed.

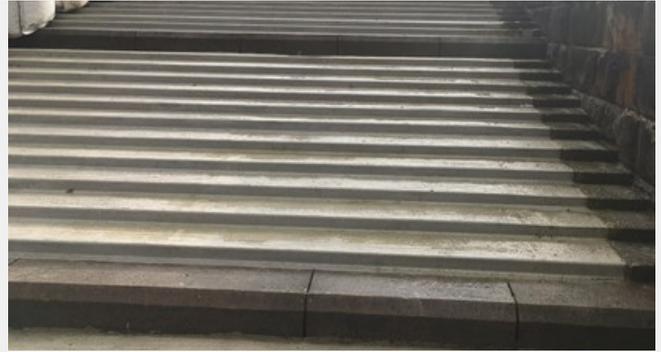
Some of the original Stone Masonry is reused with the remaining concrete channels installed with a Fibre Mix.

- To replace the original steel mesh specification, they proposed Macro Synthetic Fibre Durus S400 at a dosage of 4kg/m³.

- The concrete mix also contained Micro Synthetic Fibre, Crackstop M Ultra, at a dosage of 0.91kg/m³. The addition of Crackstop M Ultra enhanced the durability of the Concrete, subsequently maximising service life.
