Butterley Reservoir Spillway

Marsden, West Yorkshire, UK

Butterley Spillway provides an overflow to divert surplus water from the Butterley Reservoir and prevent flooding to the surrounding towns and villages. Since its construction in 1906, the Victorian Spillway had severely deteriorated over time and was in need of urgent renovation and remedial repair works.

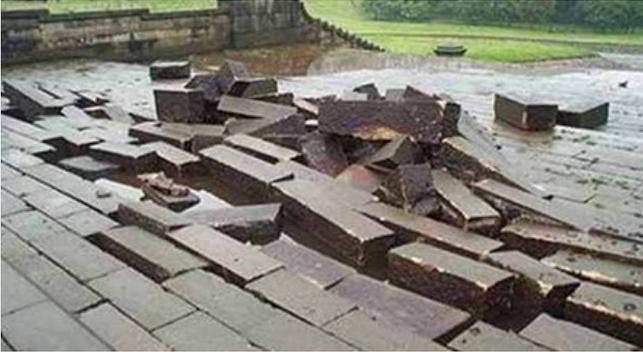
The Victorian Reservoir Overflow is handcrafted Stone Masonry and forms the Channel which is Grade II Listed.

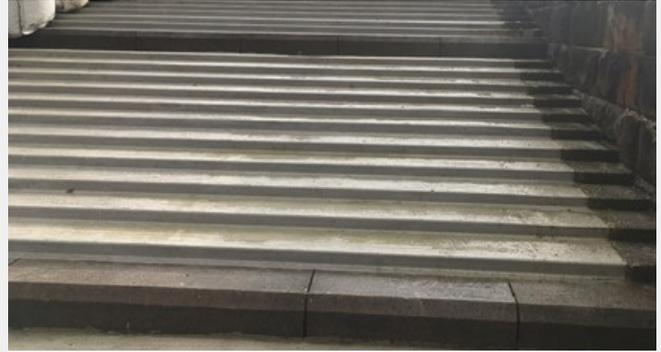
Some of the original Stone Masonry is reused with the remaining concrete channels installed with a Fibre Mix.

Initial concerns from the Local Community about preserving the natural look of the Historical Spillway were overcome as the Contractor used a combination of original handcrafted stones and the Durus macro synthetic fibre reinforced concrete. The local public and Client, Yorkshire Water, were very happy with the completed renovation, which will be part of the natural landscape for many years to come.

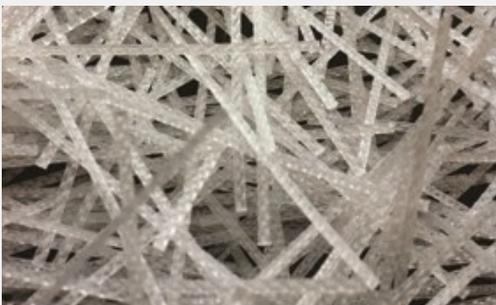
Macro Synthetic Fibre - DURUS S400 45mm

- To replace the original steel mesh specification, they proposed Macro Synthetic Fibre Durus S400 at a dosage of 4kg/m³.

As the fibres are produced from a polypropylene, there is no risk of corrosion caused by contact with the alkaline reservoir water.

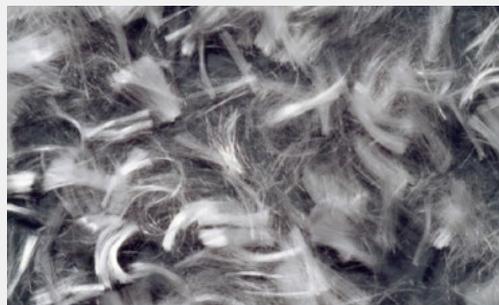
Micro Synthetic Fibre - CRACKSTOP M Ultra

- The concrete mix also contained Micro Synthetic Fibre, Crackstop M Ultra, at a dosage of 0.91kg/m³. The addition of Crackstop M Ultra enhanced the durability of the Concrete, subsequently maximising service life.
