# MAMHEAD SLIPWAY

## East Devon District Council

Exmouth, Devon, United Kingdom

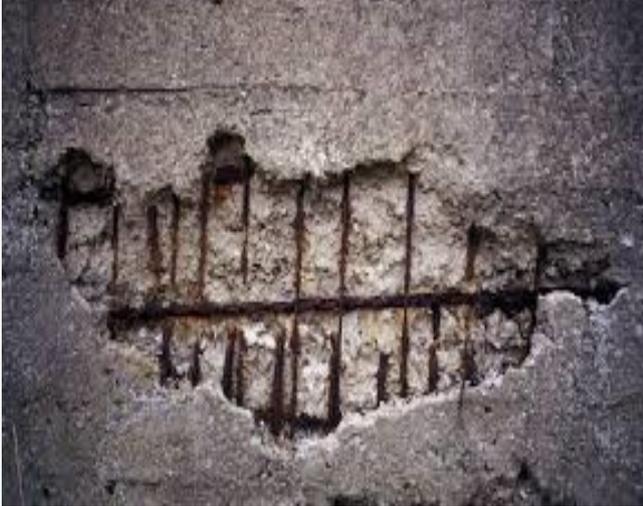
Due to the water level and tidal fluctuations, works for the slipway had to take place behind a cofferdam provided by interlocking sheet piles. This resulted in a highly restricted working area with mobile plant operating along side site operatives.

The engineering solution required a reinforced concrete slab on a 1 in 6 gradient within a confined working area, making the placement and fixing of traditional steel fabric difficult and potentially dangerous.

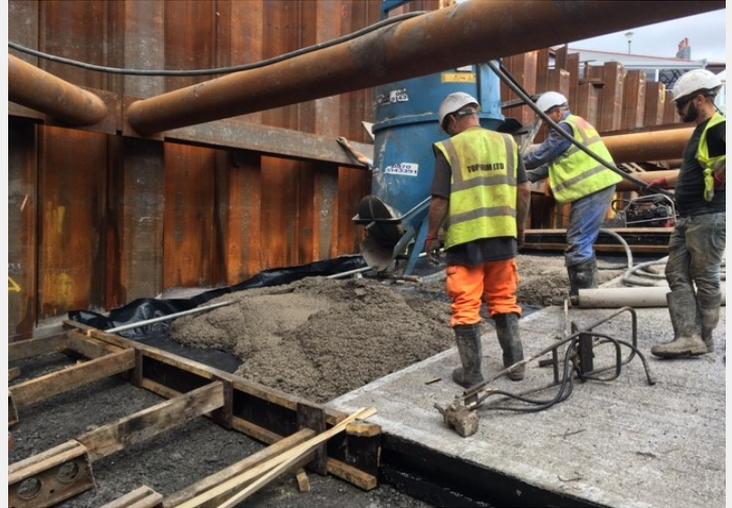
The confined nature of the site would make it difficult and dangerous to handle, cut and fix welded steel fabric. The DURUS S400 Macro Synthetic Fibre Reinforcement is contained within the concrete on delivery, so cannot be placed incorrectly or disturbed during installation.

The Macro synthetic fibre reinforced concrete can be placed directly into the formwork without the risk of misplacing welded steel mesh, potentially leading to insufficient cover and reducing performance.
